Site ID # 15530  
Inspector: Chris Gallagher

Subject: **Annual Stormwater Management Facilities Inspection Results**  
Ashford – Silver Creek  
182<sup>nd</sup> St E & 90<sup>th</sup> Ave E, Puyallup, WA 98375

Ashford (Site ID# 15530)

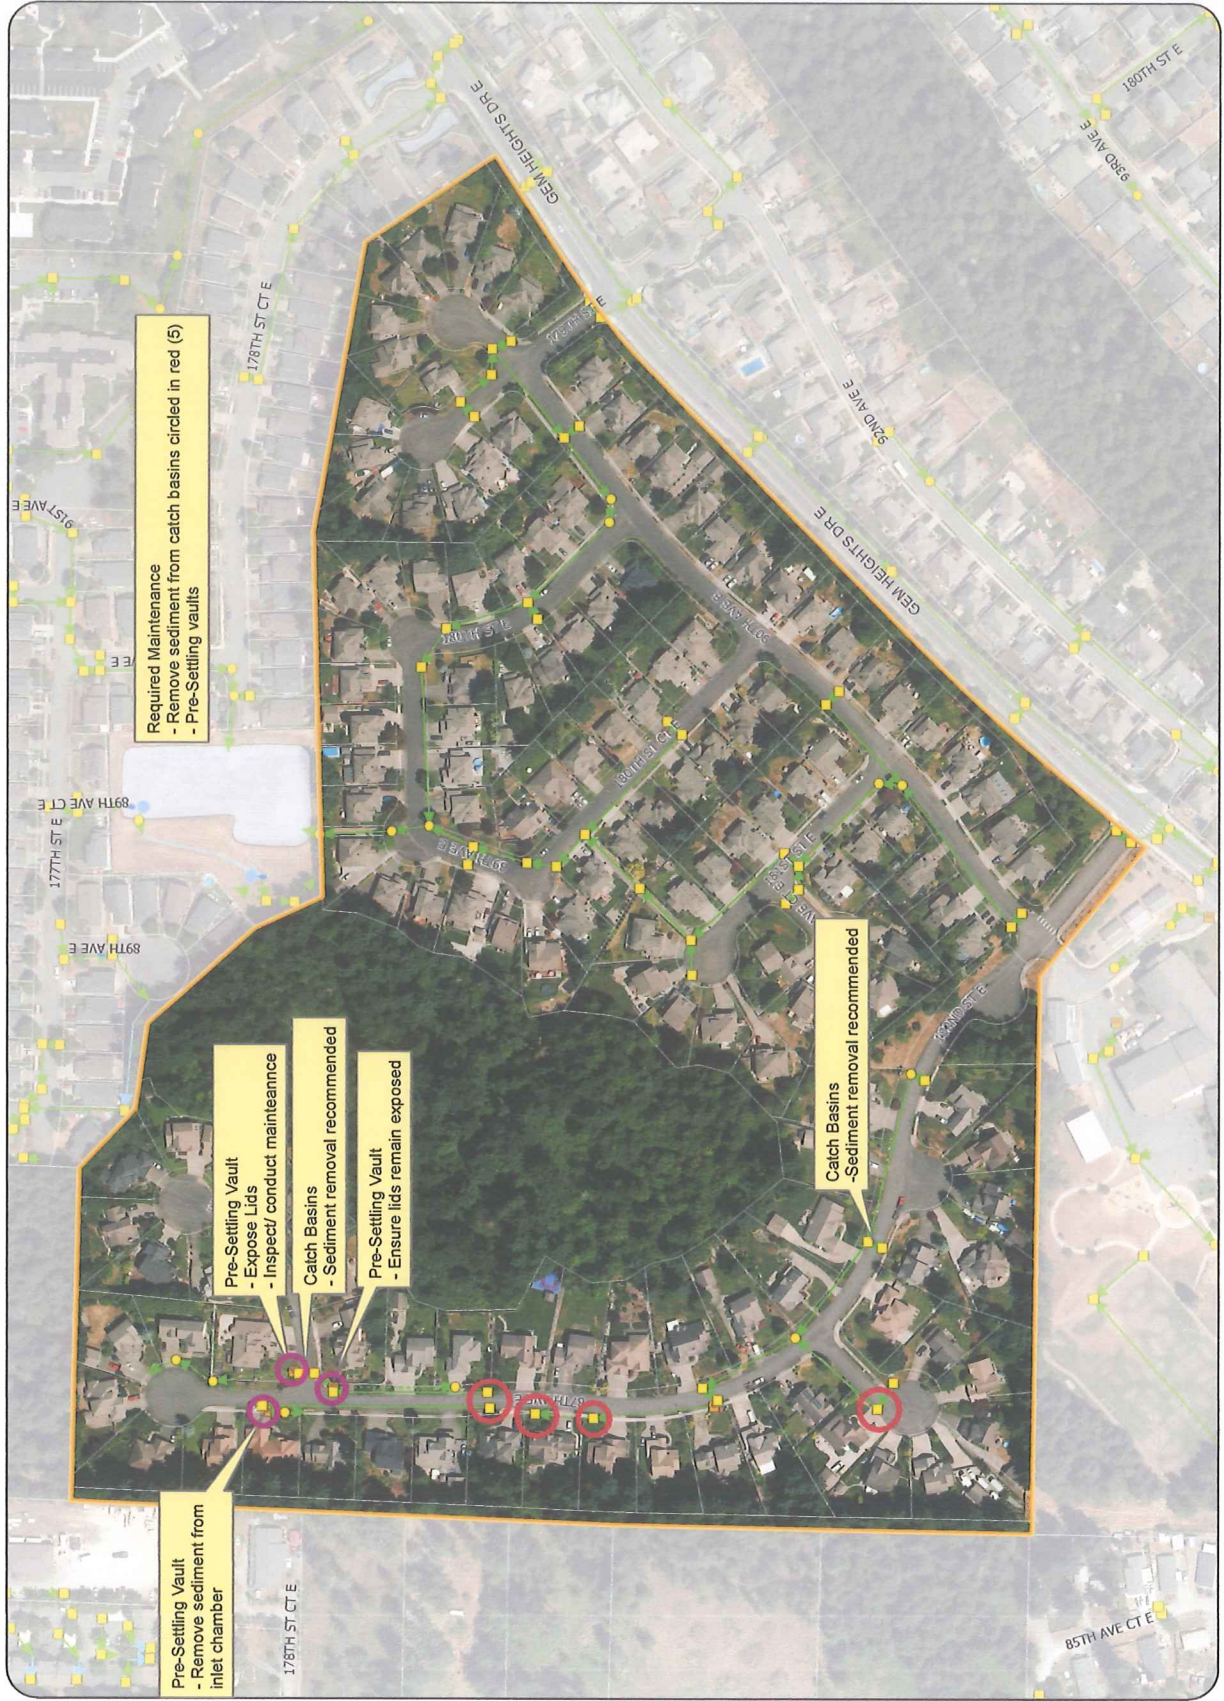
- a. Remove sediment from 5 catch basins throughout the subdivision. Sediment levels in these catch basins exceed maintenance standards. Refer to the enclosed map for the locations of the catch basins with required maintenance.

- a. Remove sediment from the inlet chamber of the northwest pre-settling vault (access through northern lid); approximately 2-feet of sediment has accumulated.
- b. Expose the access lids for the northeast pre-settling vault and inspect structure for maintenance needs. This vault is located on the northeast corner of the 178<sup>th</sup> St Ct E & 87<sup>th</sup> Ave E intersection. The lids could not be located and therefore could not be inspected.

- a. Remove sediment from 4 catch basins throughout the subdivision. Sediment levels in the catch basins that do not have required maintenance are approaching the threshold where sediment removal will be required. The location of the catch basins with recommended maintenance is identified on the enclosed map.

Required Maintenance

Network Structure -

Locate and expose the NE Wet Vault
