June 8, 2020

Site ID # 15529

Subject: **Annual Stormwater Management Facilities Inspection Results**
Premier – Silver Creek
178th St Ct E & Gem Heights Dr E, Puyallup, WA 98375

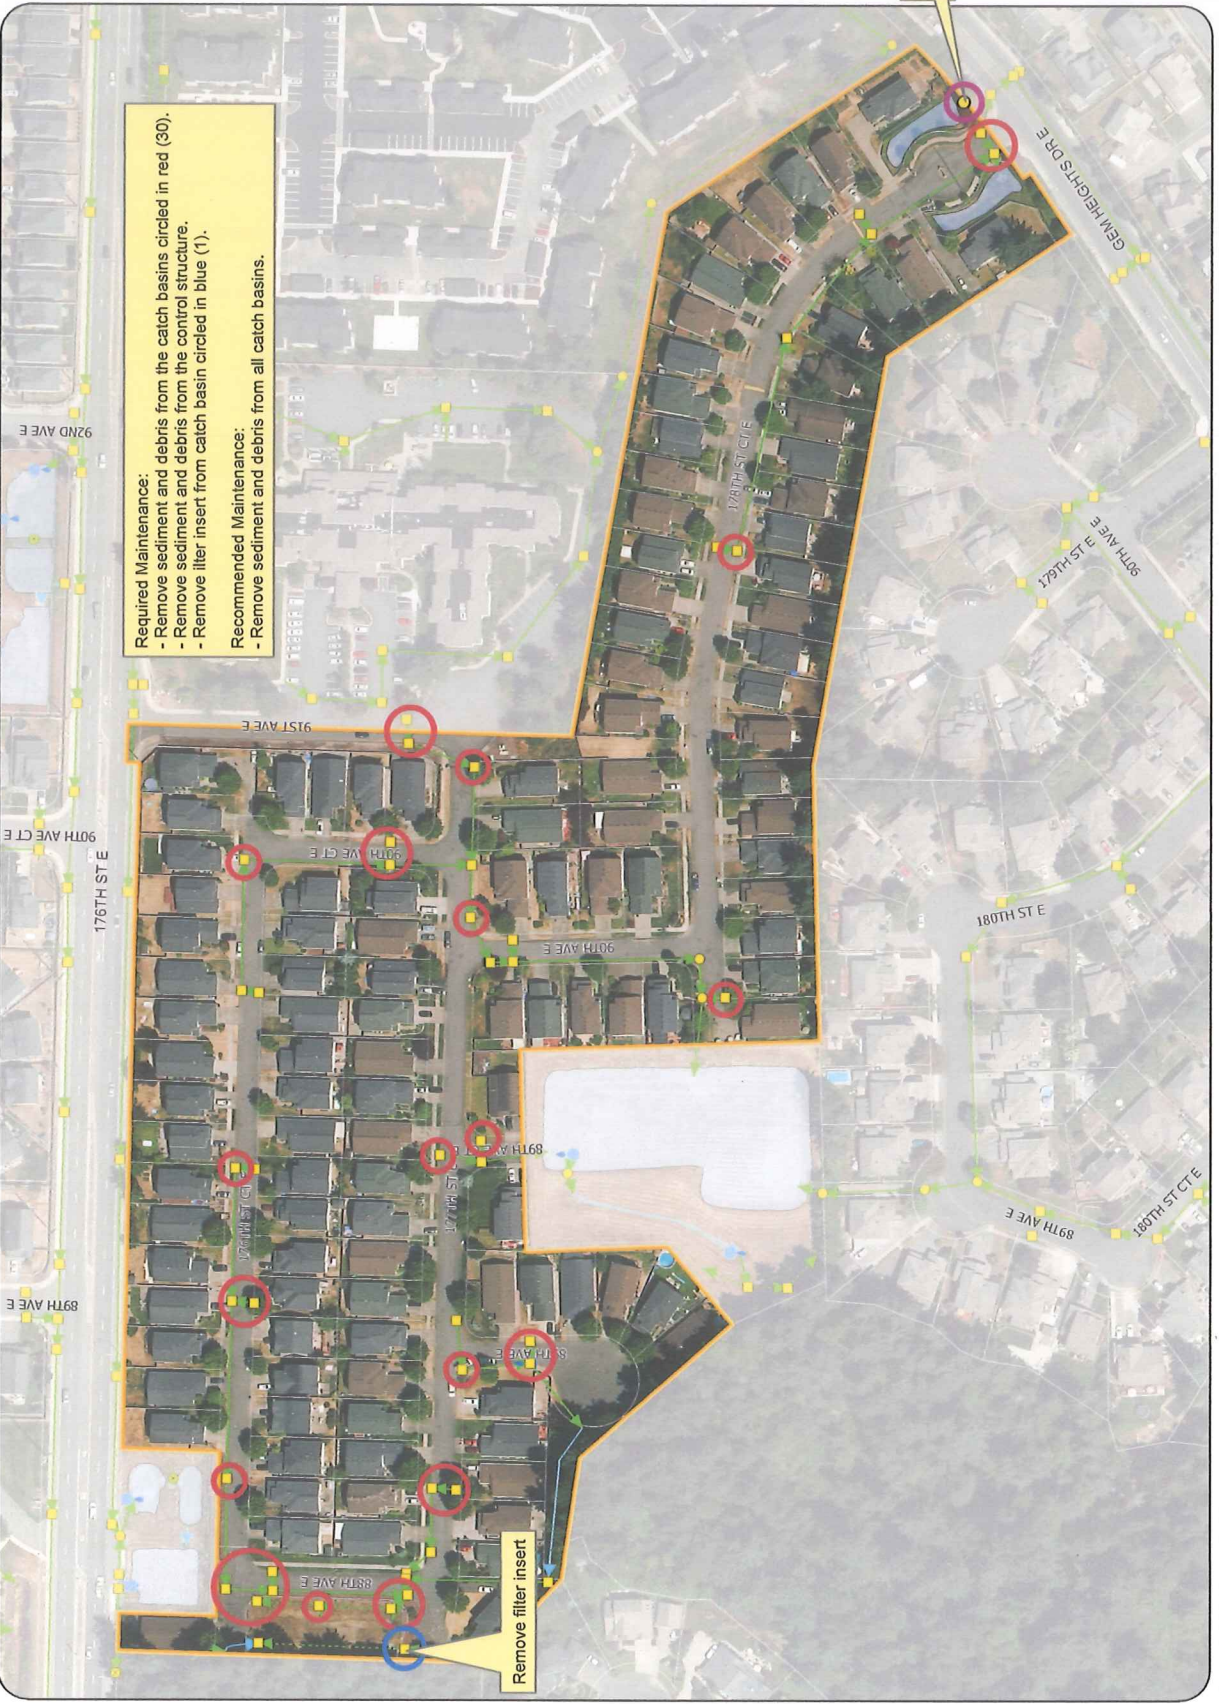
- a. Remove sediment and debris from 30 catch basins throughout the subdivision. Sediment levels in these catch basins exceed maintenance standards. Refer to the enclosed map for the locations of the catch basins with required maintenance.
- b. Remove a filter insert from one catch basin near the western pond area. Refer to the enclosed map for the location of the catch basin with the filter insert to remove.

- a. Remove sediment and debris from the control structure located just outside the pond fence near the subdivision entrance from Gem Heights Dr E. The sediment and debris level in the control structure exceed maintenance standards. Refer to the enclosed map for the location of the control structure.
