**Pierce County**  
Planning & Public Works

Site ID # 15527  
Inspector: Chris Gallagher

**Subject: Annual Stormwater Management Facilities Inspection Results**  
Southridge – Silver Creek  
87<sup>th</sup> Ave E & 184<sup>th</sup> St E, Puyallup, WA 98375

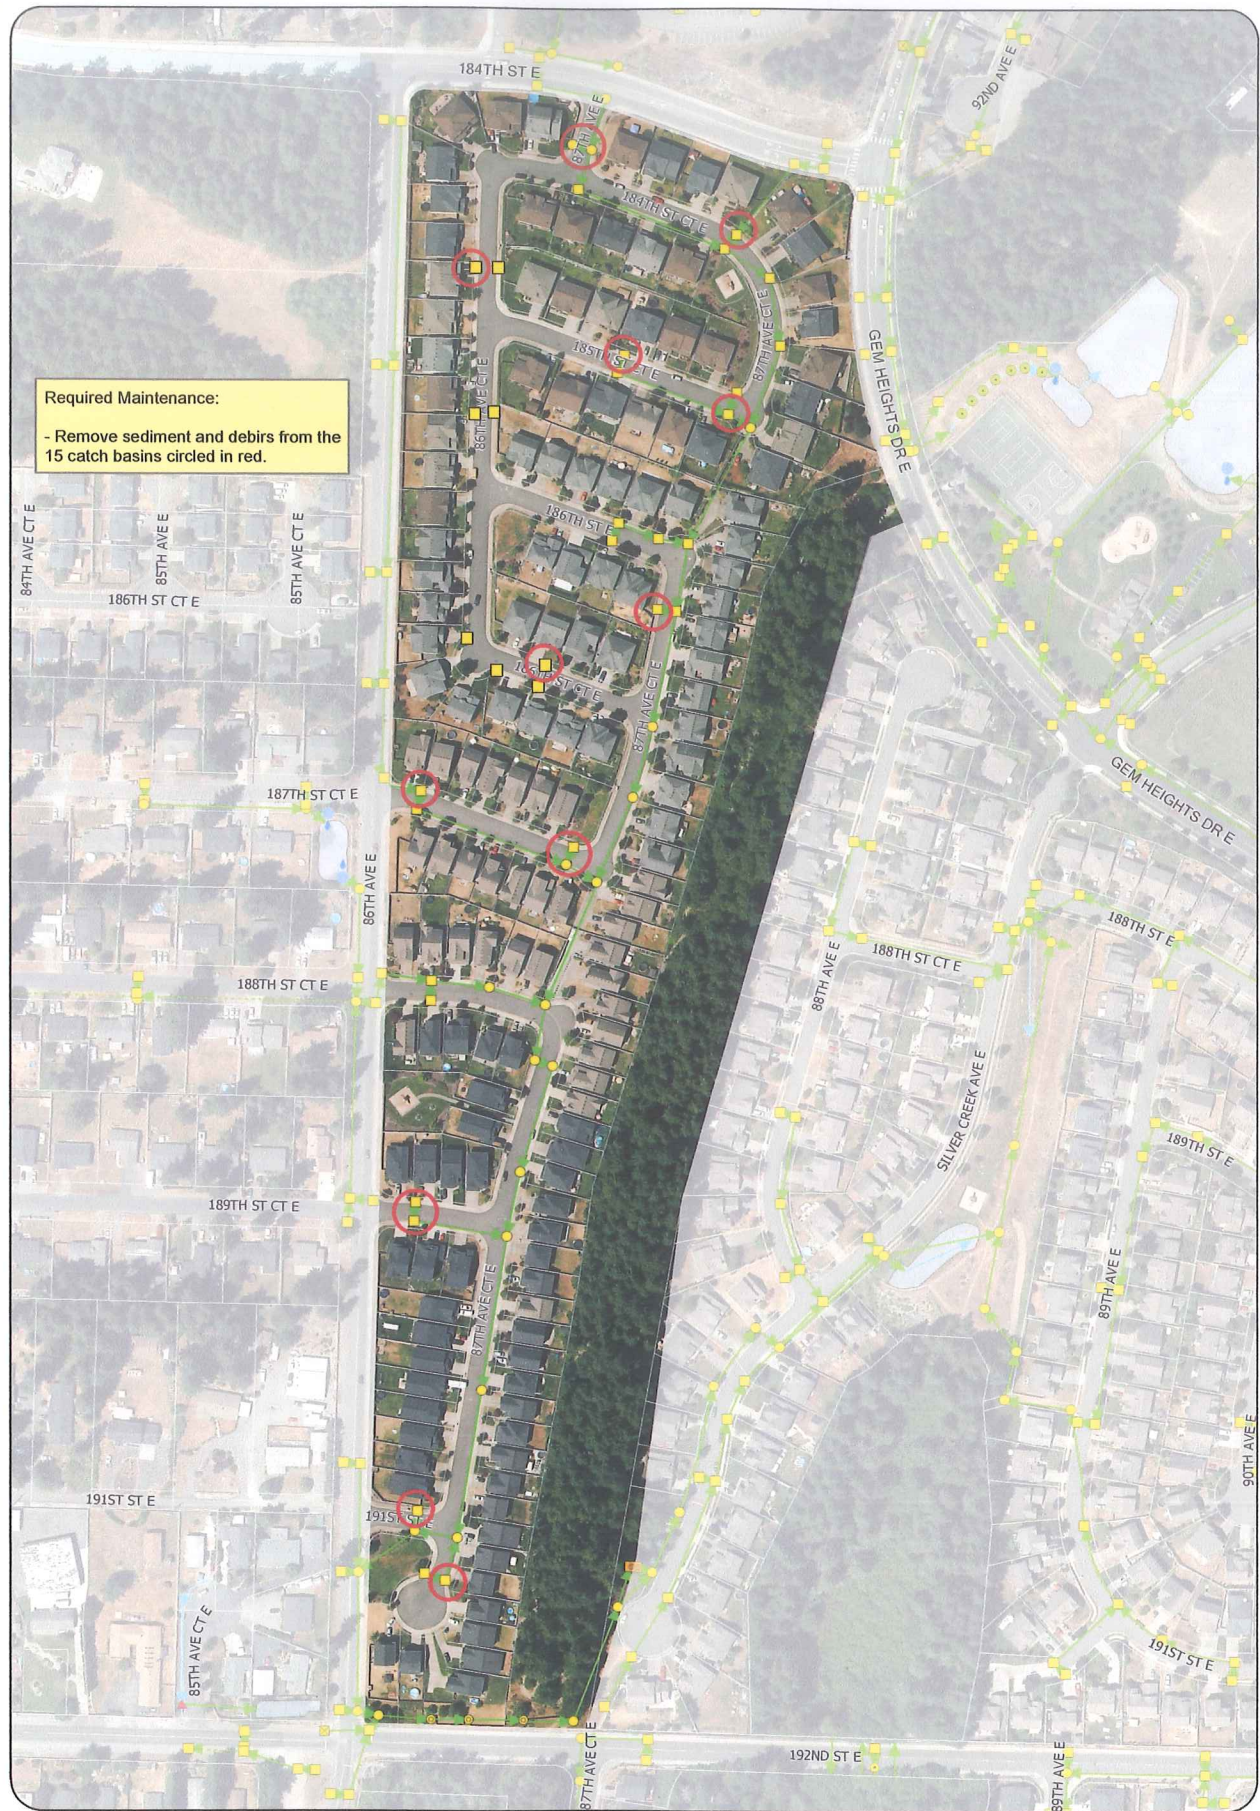
- a. Remove sediment and debris from 15 catch basins throughout the subdivision. Sediment levels in these catch basins exceed maintenance standards. Refer to the enclosed map for the locations of the catch basins with required maintenance.

- Remove sediment and debris from the 15 catch basins circled in red.
